Manhole Inspection Summary

Manhole # S25II_031MH

Insp Date: **9/6/07 10:09 AM**

Location Address: **2224 ETTING ST**

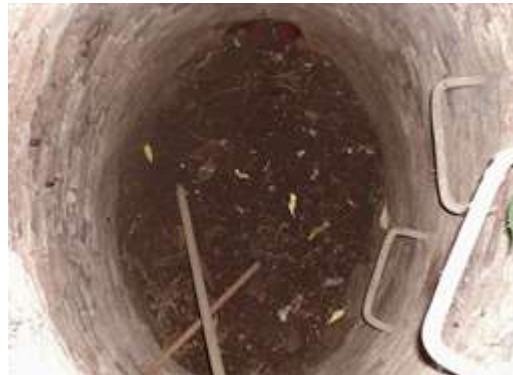
Top View

Channel debris.

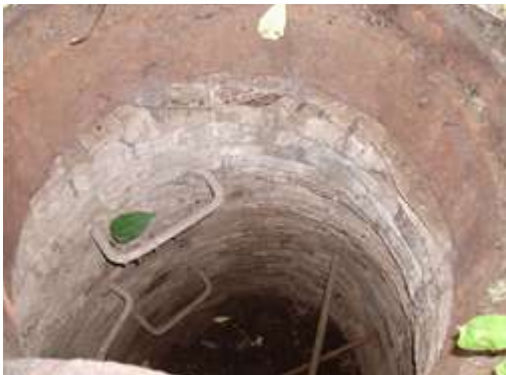
Defect

Frame leaks. Frame offset. Adjustment and Barrel infiltration.

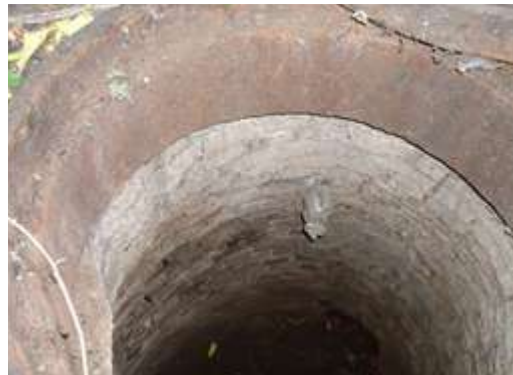
Defect

Frame leaks. Frame offset. Adjustment and Barrel infiltration - other side.

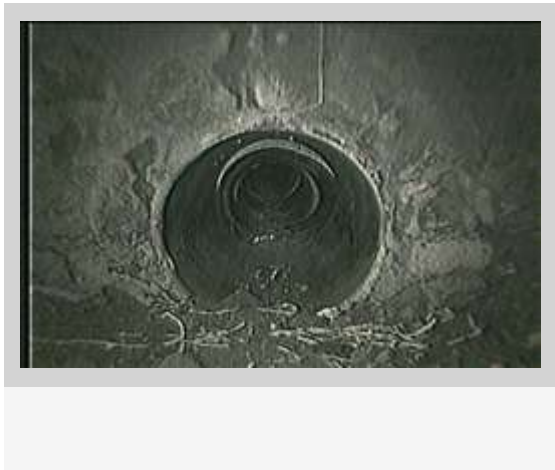
8 in. Circular Gravity Sewer
Pipe Out @ 12 O'Clock

Infiltration: **Evidence** Pipe Seal Cond: **Cracked**
